Manhole Inspection Summary

Manhole # S63G__024MH

Insp Date: **5/7/08 1:27 PM**

Location Address: **5401 Mason Lord Dr.**

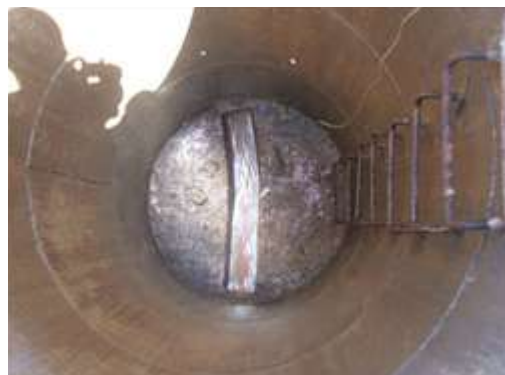
Top View

Bench ☒ Exists Material: **Brick** ☐ Parged

Condition: ☐ Sound ☐ Cracked ☐ Root Intrusion ☐ Deteriorated ☐ Leaks ☒ Debris

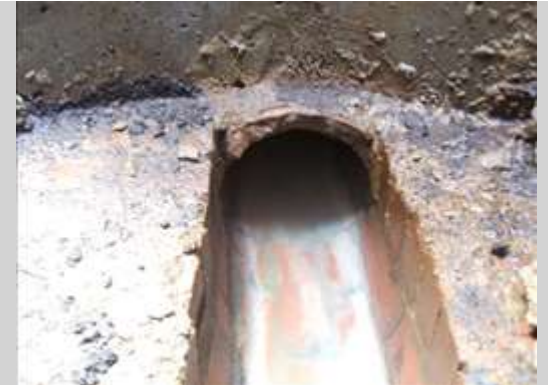
12 O'Clock Outflow

8 in. Circular Gravity Sewer
Pipe Out @ 12 O'Clock

Deposits: ☐ None ☐ Mud ☐ Sludge ☐ Debris ☒ **Grease**

Silt Depth: **0.125** (in.) Deposits Extent: **Light**

Infiltration: **None** Pipe Seal Cond: **Cracked**

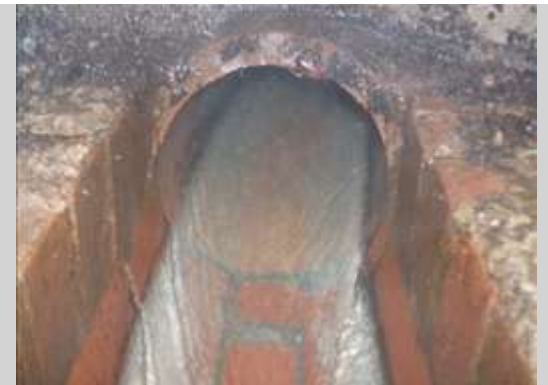
6 O'Clock Inflow

8 in. Circular Gravity Sewer
Pipe In @ 6 O'Clock

Deposits: ☐ None ☐ Mud ☐ Sludge ☐ Debris ☒ **Grease**

Silt Depth: **0.125** (in.) Deposits Extent: **Light**

Infiltration: **None** Pipe Seal Cond: **Sound**
